US Army Corps
of Engineers
Waterways Experiment
Station

Technical Report CERC-95-9
July 1995

Monitoring of the Yaquina Bay Entrance North Jetty at Newport, Oregon; Summary and Results

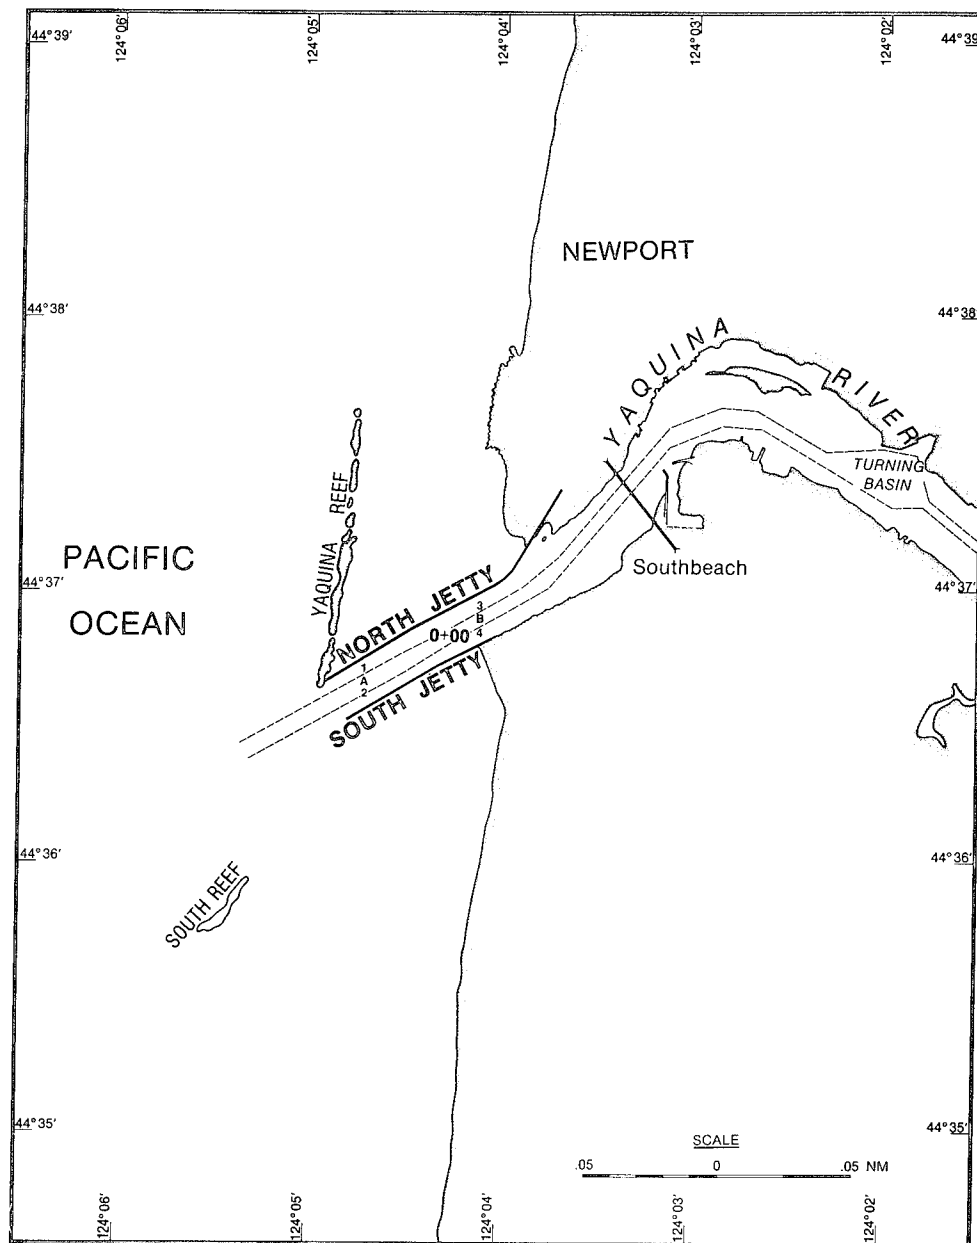
Figure 1. Yaquina Bay navigation channel jetty system¹

storms. By 1970 about 95 m (310 ft) had been lost from the tip of the north jetty as waves “beat the structure down below water level.” The partially damaged structure then appeared to reach a somewhat more stable configuration with minimal losses of jetty length occurring over the next several years.

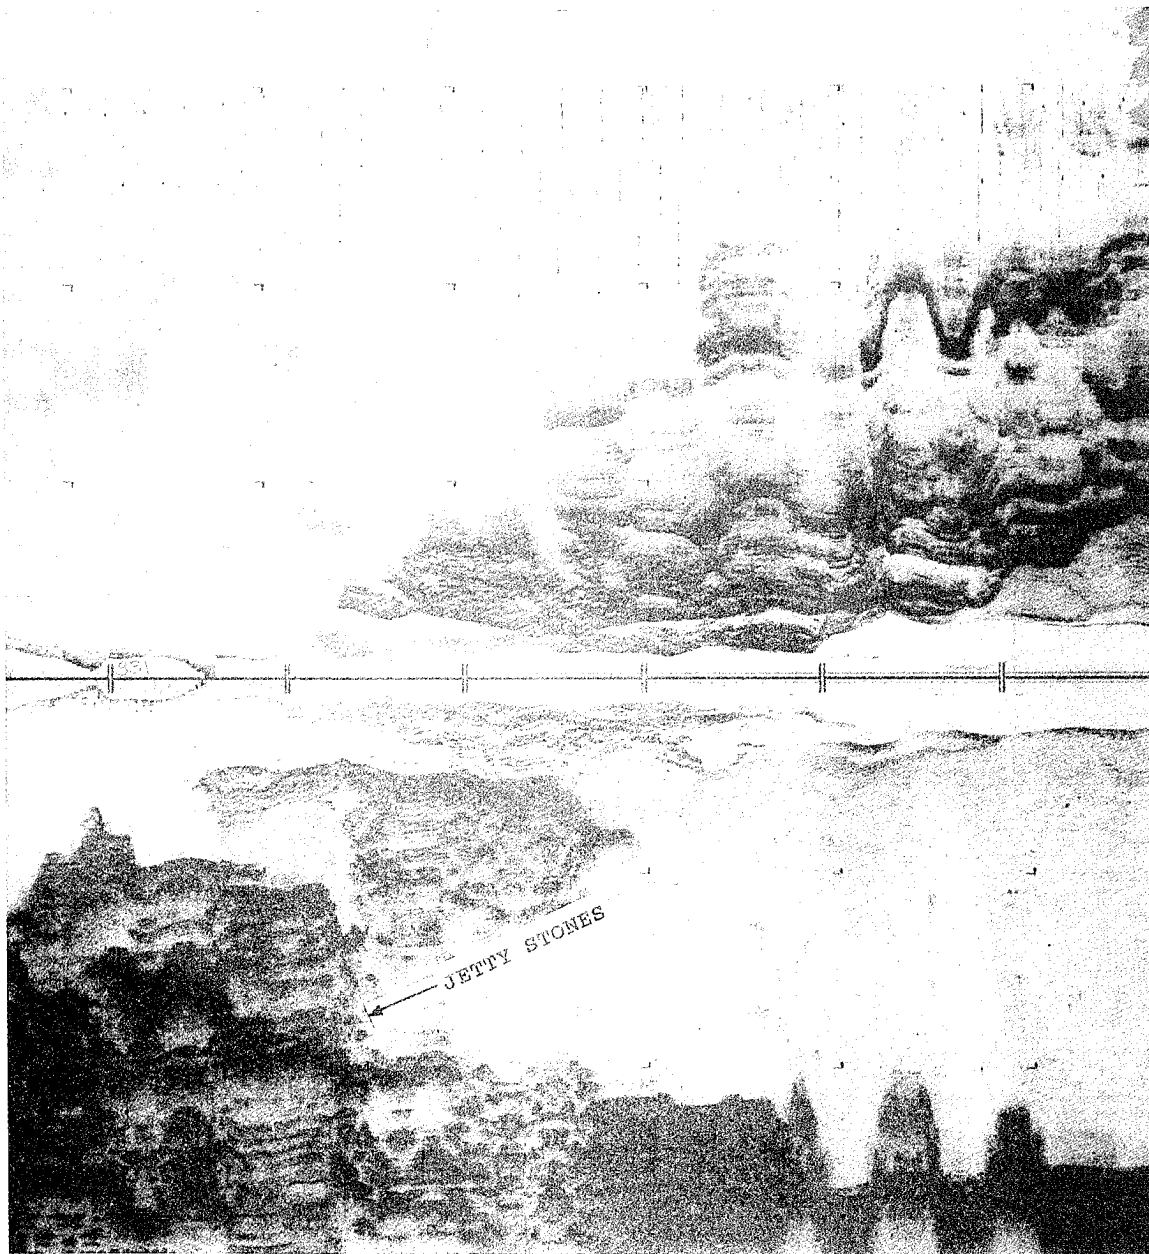
Figure 27. Side-scan sonar image from north side of the Yaquina Bay north jetty

Aided by the side-scan sonar record shown in Figure 27, the bottom echo-sounder trace of Figure 26 was interpreted to be a section of the Yaquina Reef with jetty armor stones resting on the reef, whereas the top trace of Figure 26 shows a section of the Yaquina Reef without jetty stones. The noticeable dip

evident in both echo sounder traces landward (right) of the steep eastern face of the reef was interpreted to be a scour trench in unconsolidated sediments.

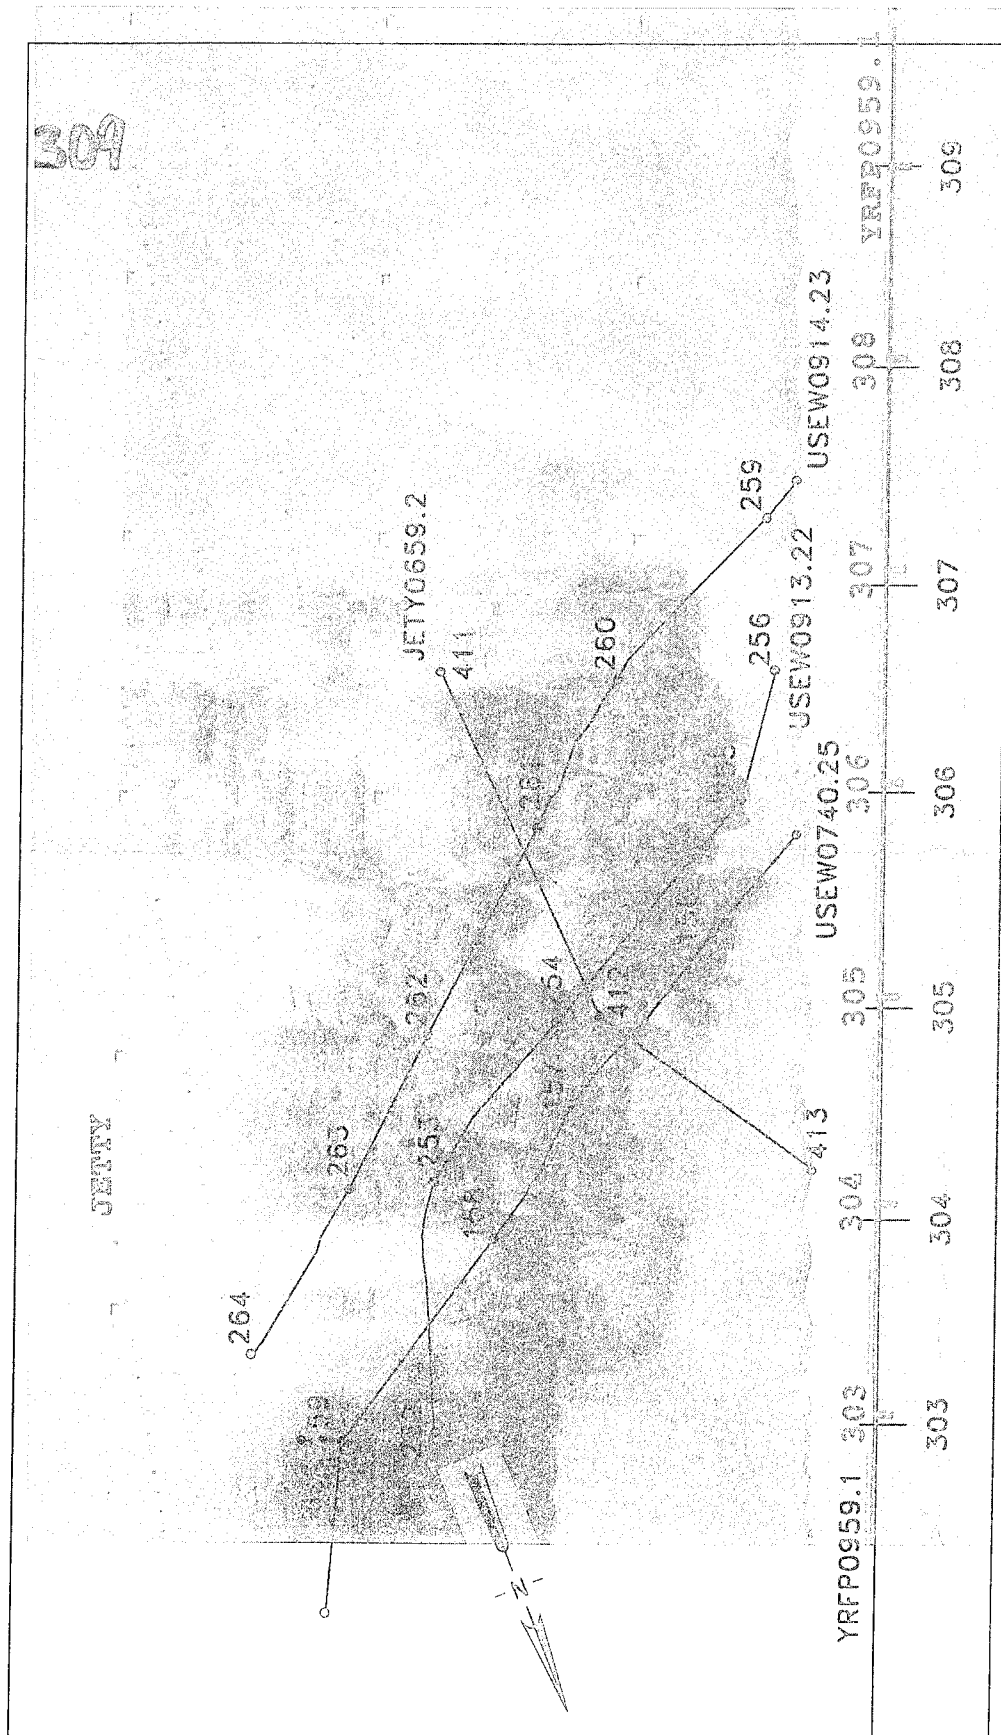
Figure 33. Side-scan sonar record along trackline YRFP0959.1 for "west side of jetty" region

Demarcation between unconsolidated sediments and reef rock is clearly discernable on the side-scan sonar image of Figure 33. This transition is just seaward of event mark 412 along trackline JETY0659.2, halfway between event marks 155 and 156 along trackline USEW0740.25, at event mark 255 along track line USEW0913.22, and halfway between event marks 259 and 260 along track line USEW0914.23.

corresponding side-scan sonar image of Figure 33 showed no rounded objects along this track line. However, there were light areas that may be areas of sand. The interpretation from the echo sounder and side-scan sonar data is that trackline JETY0659.2 passed entirely over reef rock which contained isolated sand pockets overlaying the Yaquina Reef.

The side-scan sonar image of Figure 33 was too dark to permit a clear interpretation along echo sounder track line USEW0913.22 in the region of event mark 252. Therefore, the bathymetric profile around event mark 252 cannot be interpreted with certainty. The small regular roughness elements present on this profile in Figure 34 around event mark 253 exhibit the shape of overlapping jetty armor stones, and this interpretation is confirmed by the rounded images returned from the side-scan sonar around this event mark. The bathymetric profile also has the smooth hummocky appearance of reef rock between the offshore boundary of the reef at event mark 255, shoreward until event mark 254. The conclusion for echo sounder trackline USEW0913.22 was that the track line crossed from unconsolidated sediments to reef rock near event mark 255 and passed over the Yaquina Reef until event mark 254, where the trackline crossed over the north jetty toe.

The bathymetric profile for trackline USEW0914.23 on Figure 34 shows a region of roughness elements between event marks 262 and 264 that have correct dimensions to be individual jetty armor stones. Rounded objects that appear to be jetty armor stones are clearly seen in this region in the Figure 33 side-scan sonar image. From event mark 262 seaward to halfway between event marks 260 and 259 the rock formation has the smooth hummocky appearance of the Yaquina Reef. Therefore, echo sounder trackline USEW0914.23 passed over the seaward edge of the reef between event marks 259 and 260, crossed over the reef until event mark 262, then crossed over the toe of the north jetty.

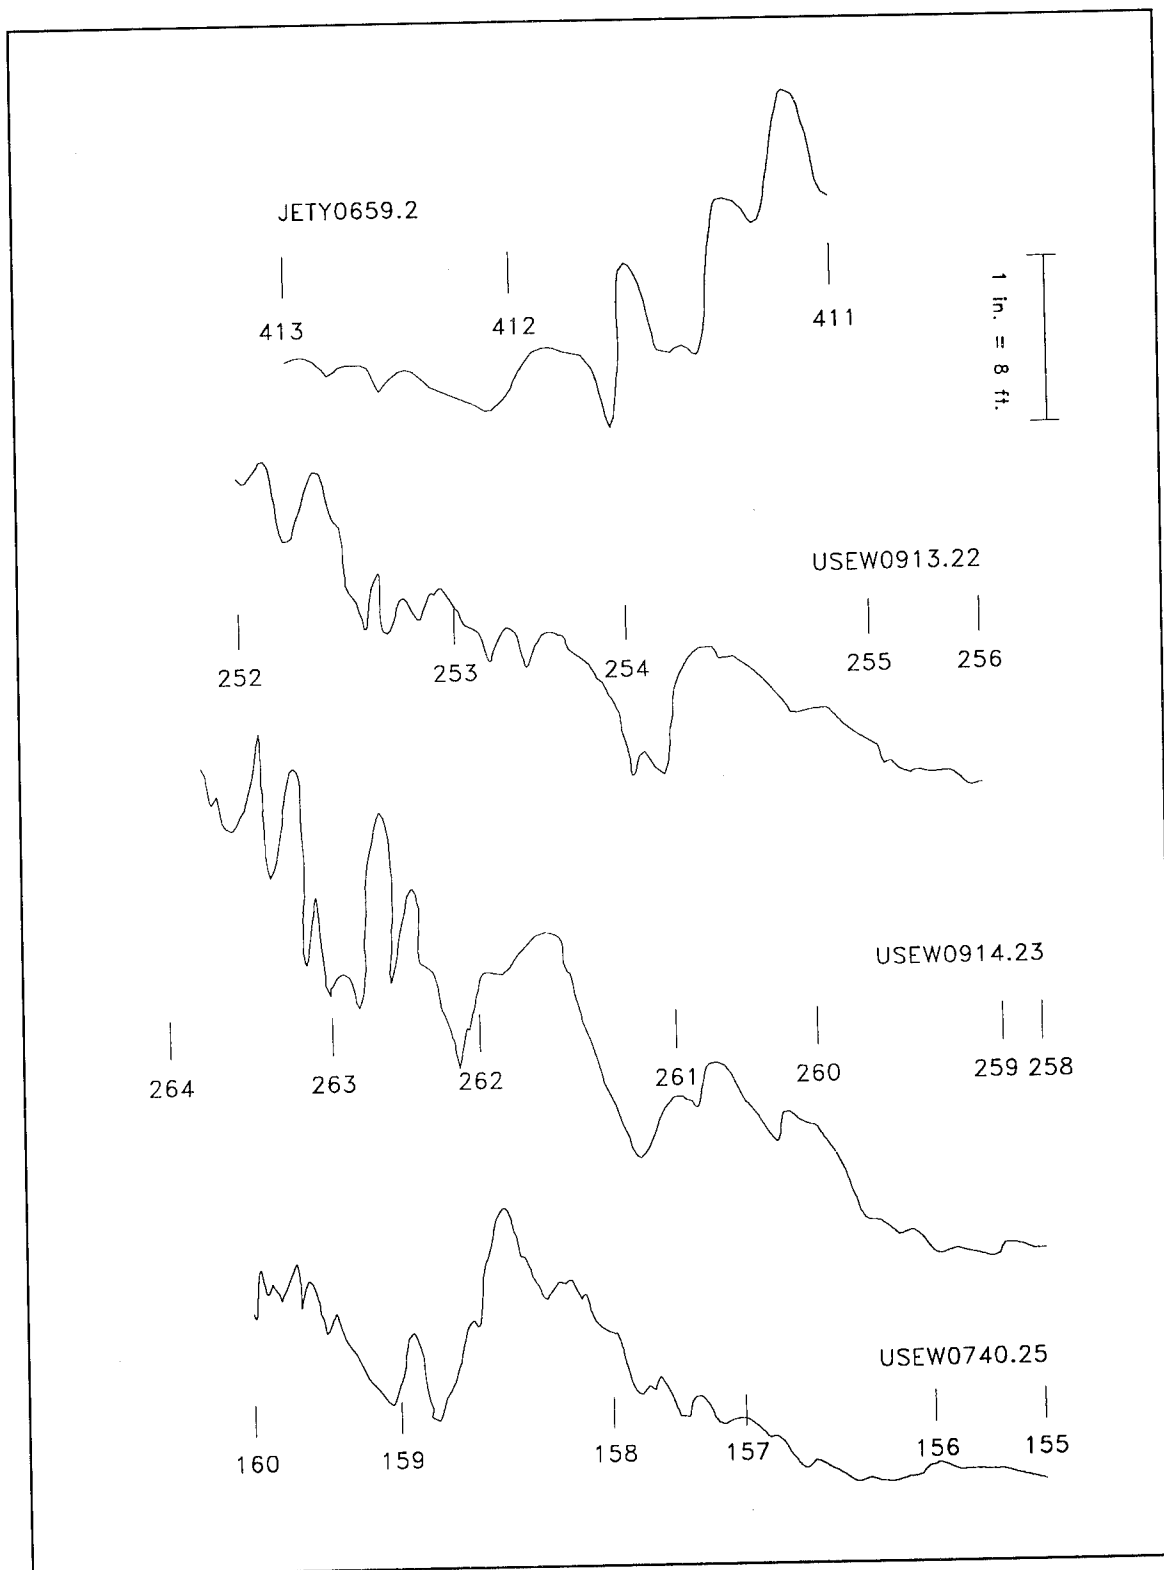
Figure 34. Echo sounder profiles for "west side of jetty" region

The bathymetric profile for track line JETY0659.2 shown on Figure 34 is relatively smooth, and the large roughness elements are generally wider in the horizontal and shorter in the vertical than those of individual jetty stones. The

The bathymetric profile for trackline USEW0740.25 shown on Figure 34 is also relatively smooth until halfway between event marks 159 and 160. Unfortunately, the corresponding side-scan sonar image is no help in this region because the return signal is very dark, and it is hard to discern any rounded features. It was tentatively concluded that trackline USEW0740.25 crossed over the seaward edge of the Yaquina Reef between event marks 155 and 156, and passed over the reef until between event marks 159 and 160 where small, regularly spaced roughness elements were recorded that may be overlapping jetty armor stones.

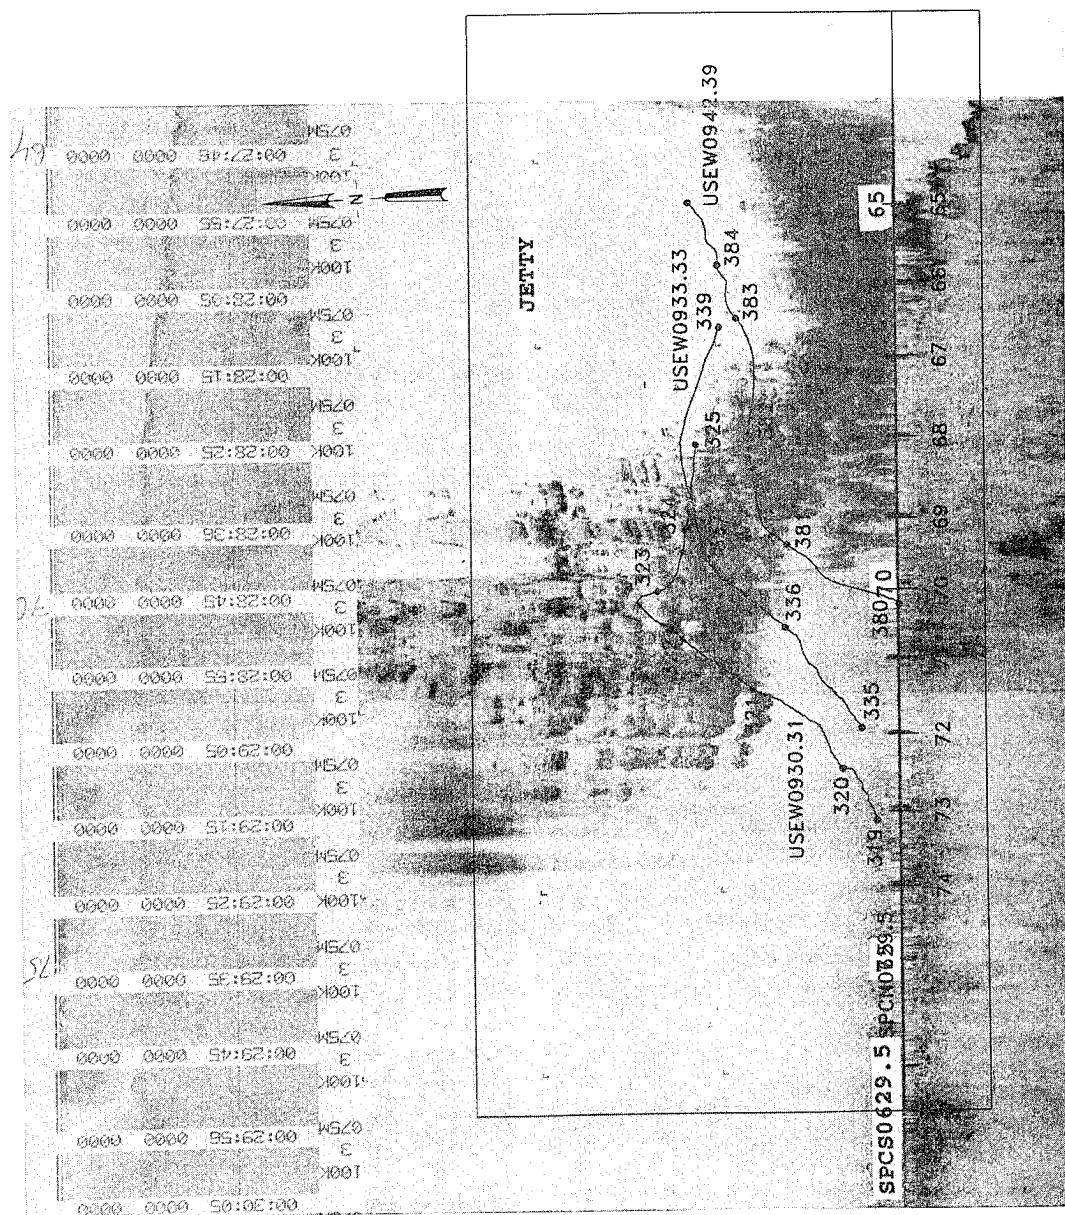
Figure 35. Side-scan sonar record along trackline SPCS0629.2 for "southwest side of jetty" region

The side-scan sonar image of Figure 35 indicated that the transition from offshore unconsolidated sediments to rock occurred along echo sounder track-line USEW0930.31 near event mark 321, along track line USEW0933.33 between event marks 336 and 337, and along trackline USEW0942.39 between event marks 381 and 382. All three bathymetric profiles on Figure 36 showed a large scour trench just seaward of the rock area (southwest of the north jetty tip).

The identified rock portions of all three bathymetric profiles contained small regularly spaced roughness elements characteristic of overlapping jetty armor stones. Rounded objects were also seen in the Figure 35 side-scan sonar image over all portions that were indicative of rock. None of the bathymetric profiles had portions containing the smooth hummocky appearance of reef rock, with the possible exception of around event mark 322 along trackline USEW0930.31. However, the interpretation of these data in conjunction with other data led to the conclusion that there is no exposed reef in this immediate area. The presence of the deep scour trench immediately seaward of the jetty supports the contention that the toe of the north jetty in this region is resting on sand rather than resting on a portion of the reef that was covered with sand.

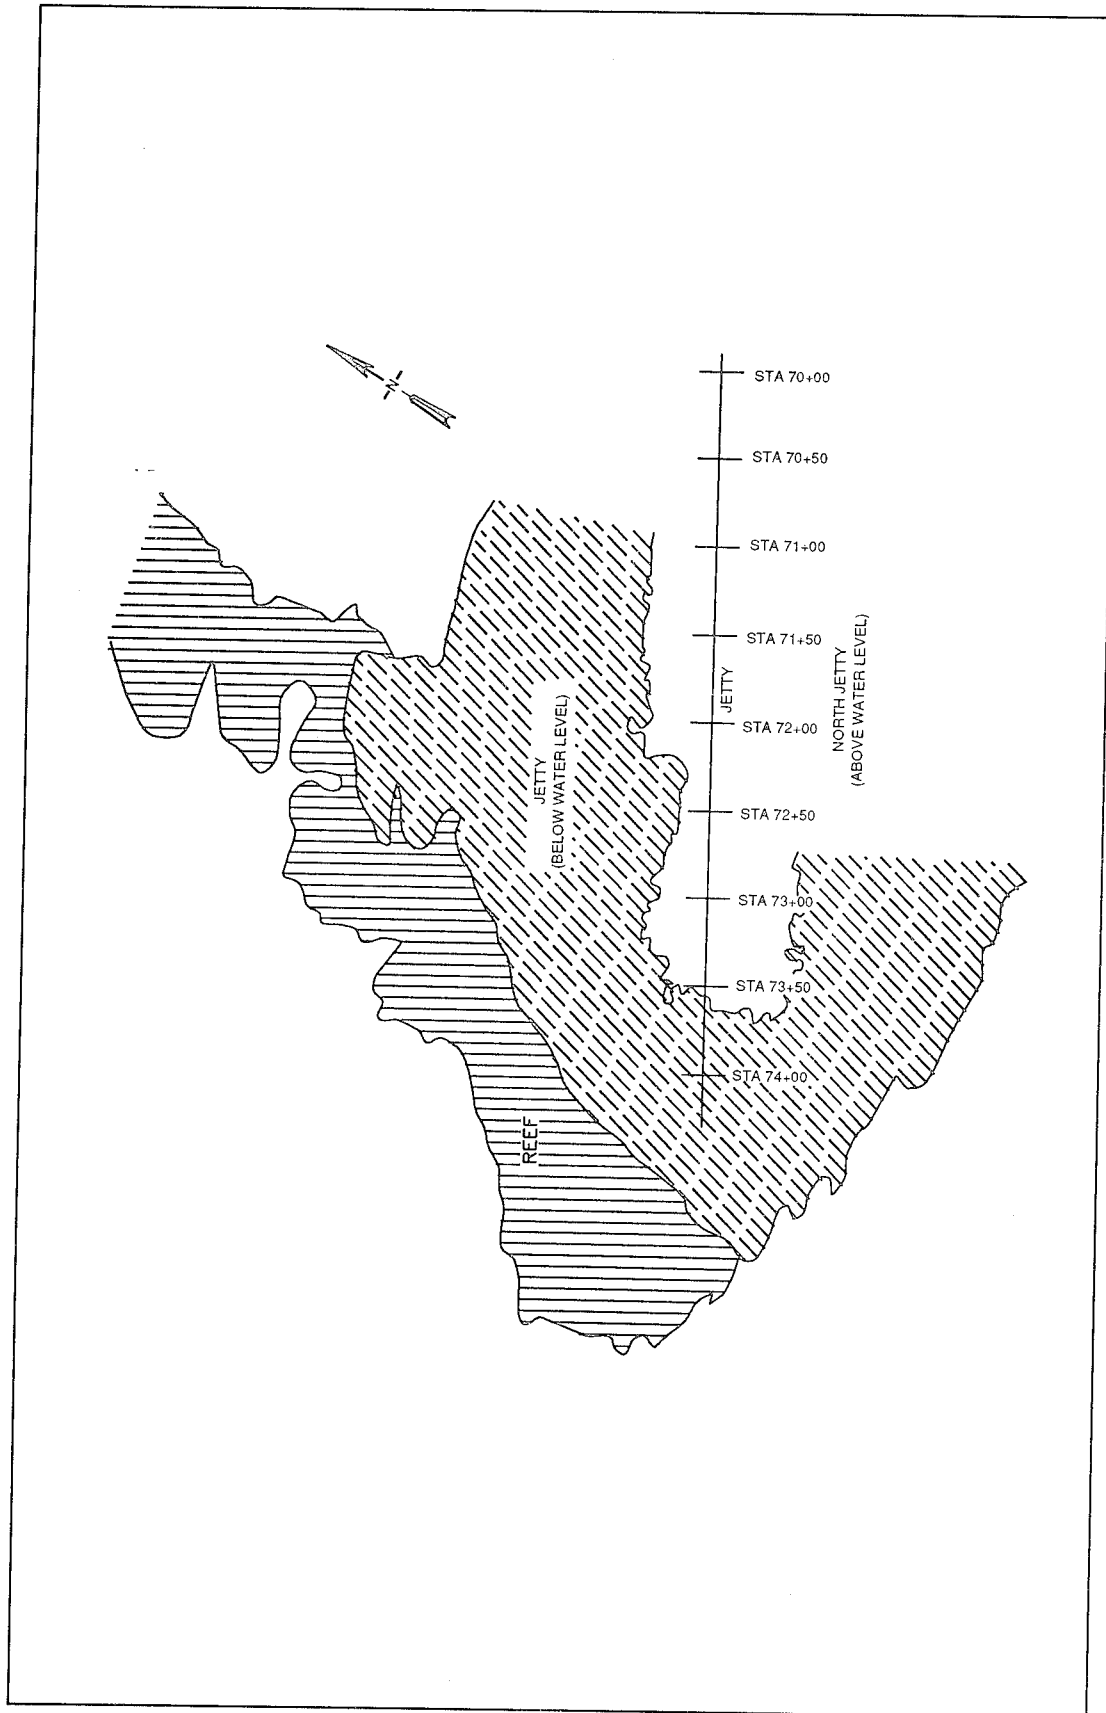
Figure 37. Position of Yaquina Bay north jetty relative to Yaquina Reef

portion of the Yaquina Reef sticks out seaward of the northwest tip of the Yaquina Bay north jetty. However, interpreting roughness elements on the bathymetric profiles as jetty armor stones involved a certain degree of subjectivity. Therefore, the line marking the toe of the north jetty on Figure 37 is not absolutely definitive.

Analysis and interpretation of side-scan sonar and echo sounder data have determined the location and extent of reef not covered by jetty armor stones, as shown on Figure 37. This interpretation agreed well with the rendition of the reef shown in Figure 4. Based on the foregoing analysis, it was concluded that the Yaquina Reef extends seaward of the north jetty toe for a maximum distance of approximately 30 m (100 ft) on the west side and a minimum distance of about 15 m (50 ft) on the northwest side.

Figure 37 also shows a "bulb" of jetty armor stone located on the north side of the jetty and overlaying the landward side of the Yaquina Reef. This pile of armor stones has approximate dimensions of 30 m (100 ft) in the east-west direction with a width of about 15 m (50 ft). Further to the west (seaward) of this pile of armor stones, but still along the north side of the jetty, a stretch of bare reef extends 15 m (50 ft) northward of the jetty.

The results presented in this chapter support the accuracy of the chart shown in Figure 4, which clearly located the tip of the Yaquina Bay north jetty overlaying the Yaquina Reef. Furthermore, the location of the jetty toe relative to the above-water edge of the jetty structure indicated the jetty has a below-water structure slope that is substantially milder than originally thought (1:4 in some places). In retrospect this was not surprising because a milder below-water slope helps to account for armor stones lost from the jetty during prior damage sequences. In other words, as damage occurred, armor stones above the mllw level were carried down-slope and deposited near the toe. This eventually resulted in a wide foundation on which the last jetty rehabilitation was built. Unfortunately, there were insufficient data for a volumetric calculation of excess stone in the jetty foundation.

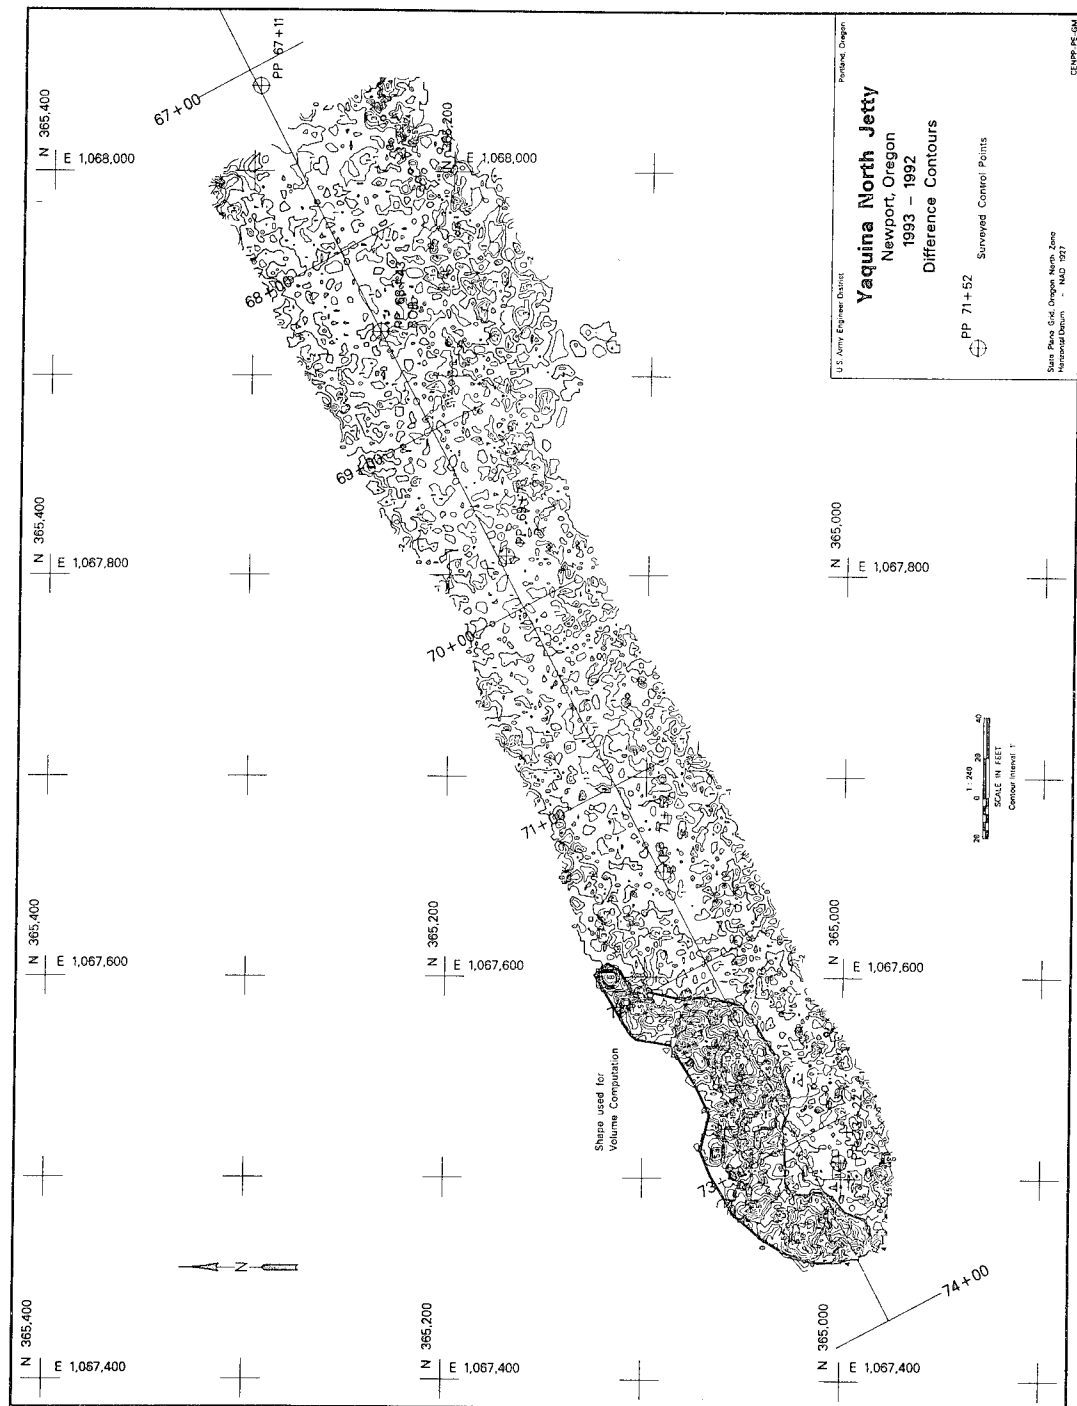
Figure 43. Difference between 1992 and 1993 north jetty contours

As mentioned, gridded elevations from different dates can be combined to produce difference contours. Figure 43 shows the difference contours found between stereo models for the 1992 and 1993 overflights. This figure is included only to give an impression of the product. The original products

have different colored contours to denote positive and negative differences, and they are far more informative than what is shown in black and white on Figure 43.

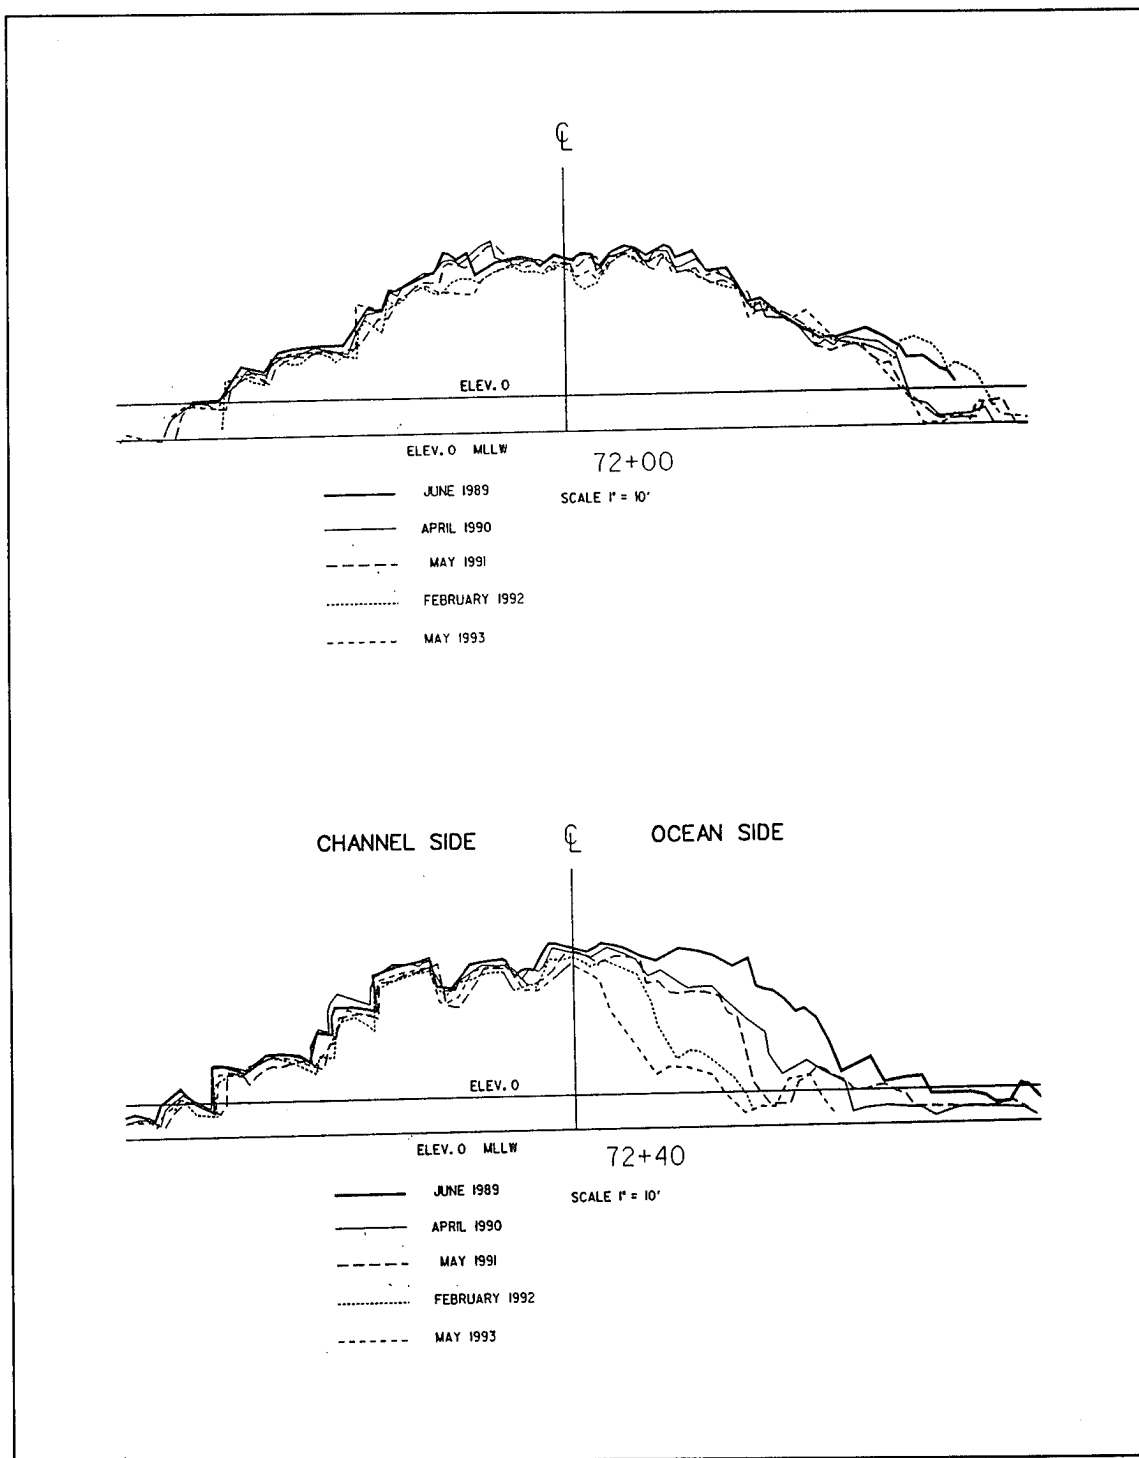
Figure 45. Stereo model jetty profile comparisons, ranges 72+00 and 72+40

- c. The most profile change occurred in the vicinity of the "notch" (Figure 45, range 72+40). Significant damage occurred between the years 1989 - 1991. This was followed by a year when the only armor stone losses in the notch area occurred on the landward side of the notch. However, between the 1992 and 1993 overflights, massive profile losses occurred in the notch area to the extent that stones were lost over much of the structure's crest (see range 72+70, Figure 46).

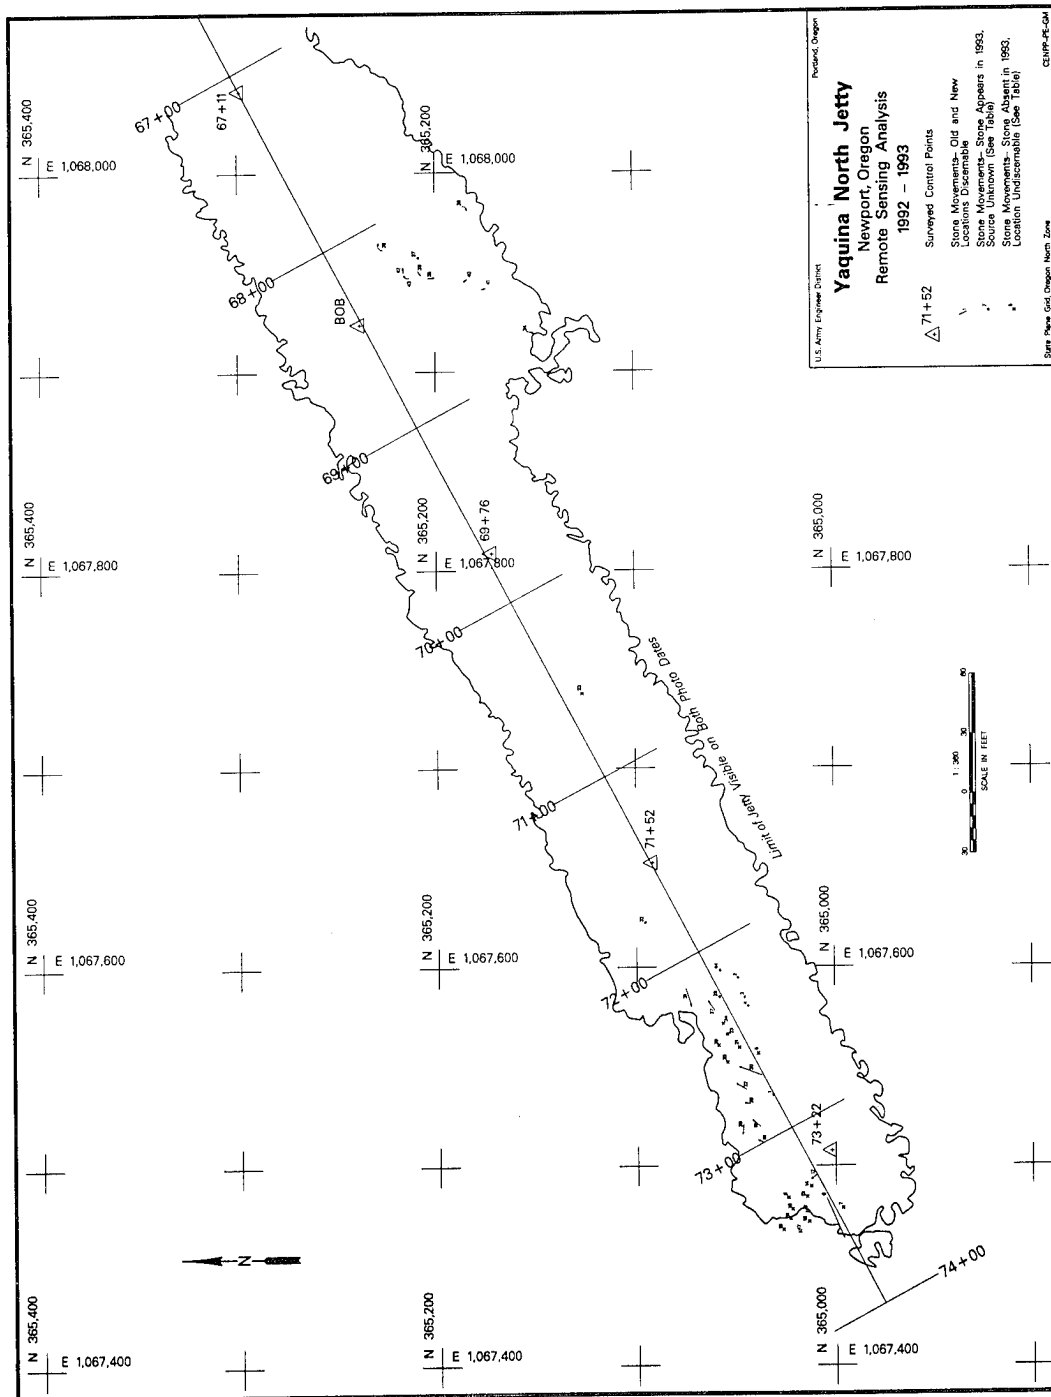
Figure 50. Individual armor stone movement between 1992 and 1993

The winter season between 1992 and 1993 resulted in the loss of approximately 17 identifiable armor stones as determined from aerial photography. Ten of the larger select class "A" stones were lost from the previously stable region at the very tip of the north jetty as shown on the stone movement drawing (Figure 50). More stones were undoubtedly lost from underneath the removed top stones, but the actual number cannot be determined because they cannot be identified on the earlier photographs. Curiously, eight stones on the 1993 photographs were identified that were not present in the 1992 photographs. It is presumed that these armor stones, located high on the crest near the jetty center line, were swept up the structure slope from the notch area or from somewhere below the waterline. Also, some stone movement was noted on the channel side of the north jetty around Station 68+50 (see Figure 50).

Figure 51 summarizes the stone movements that occurred between 1992 and 1993. Although most stone movements were less than 2 m (7 ft), there was one stone near the notch that moved about 3.4 m (11 ft) downslope and one stone at the tip that was displaced a total of 6.4 m (21 ft).

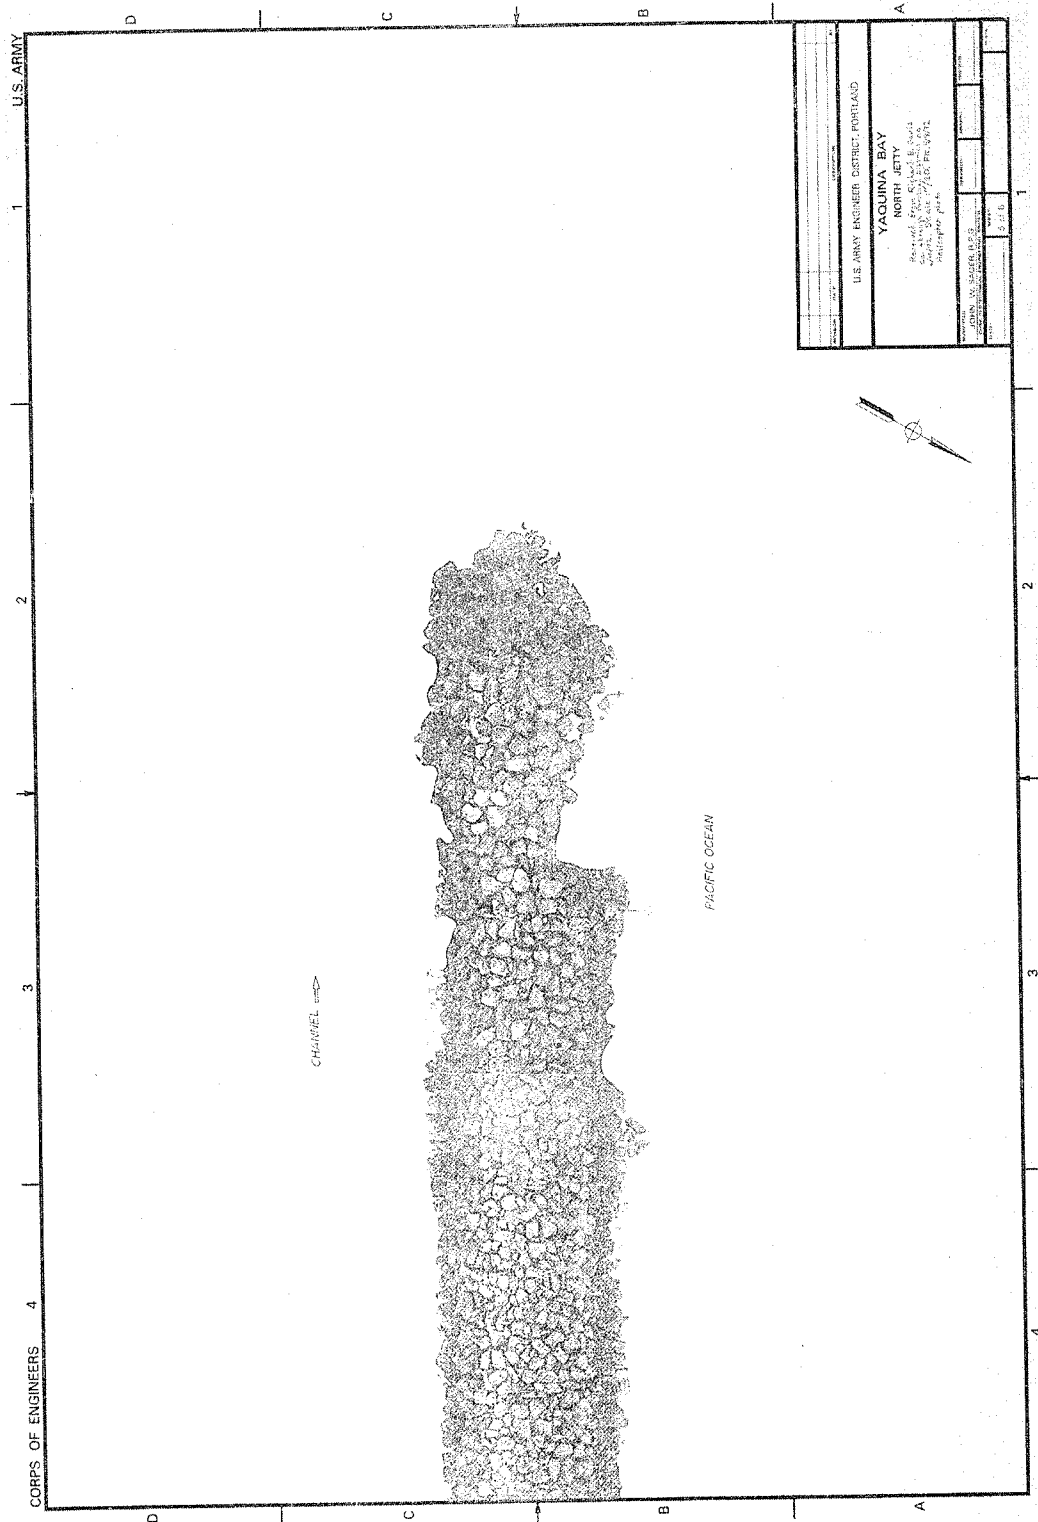
Figure 54. Helicopter photograph of Yaquina Bay north jetty tip, 1992

Figure 54 shows a composite photograph of the seaward tip of the north jetty acquired during the 1992 helicopter overflight. Figure 55 shows the contours developed from the photogrammetry, similar to the fixed-wing

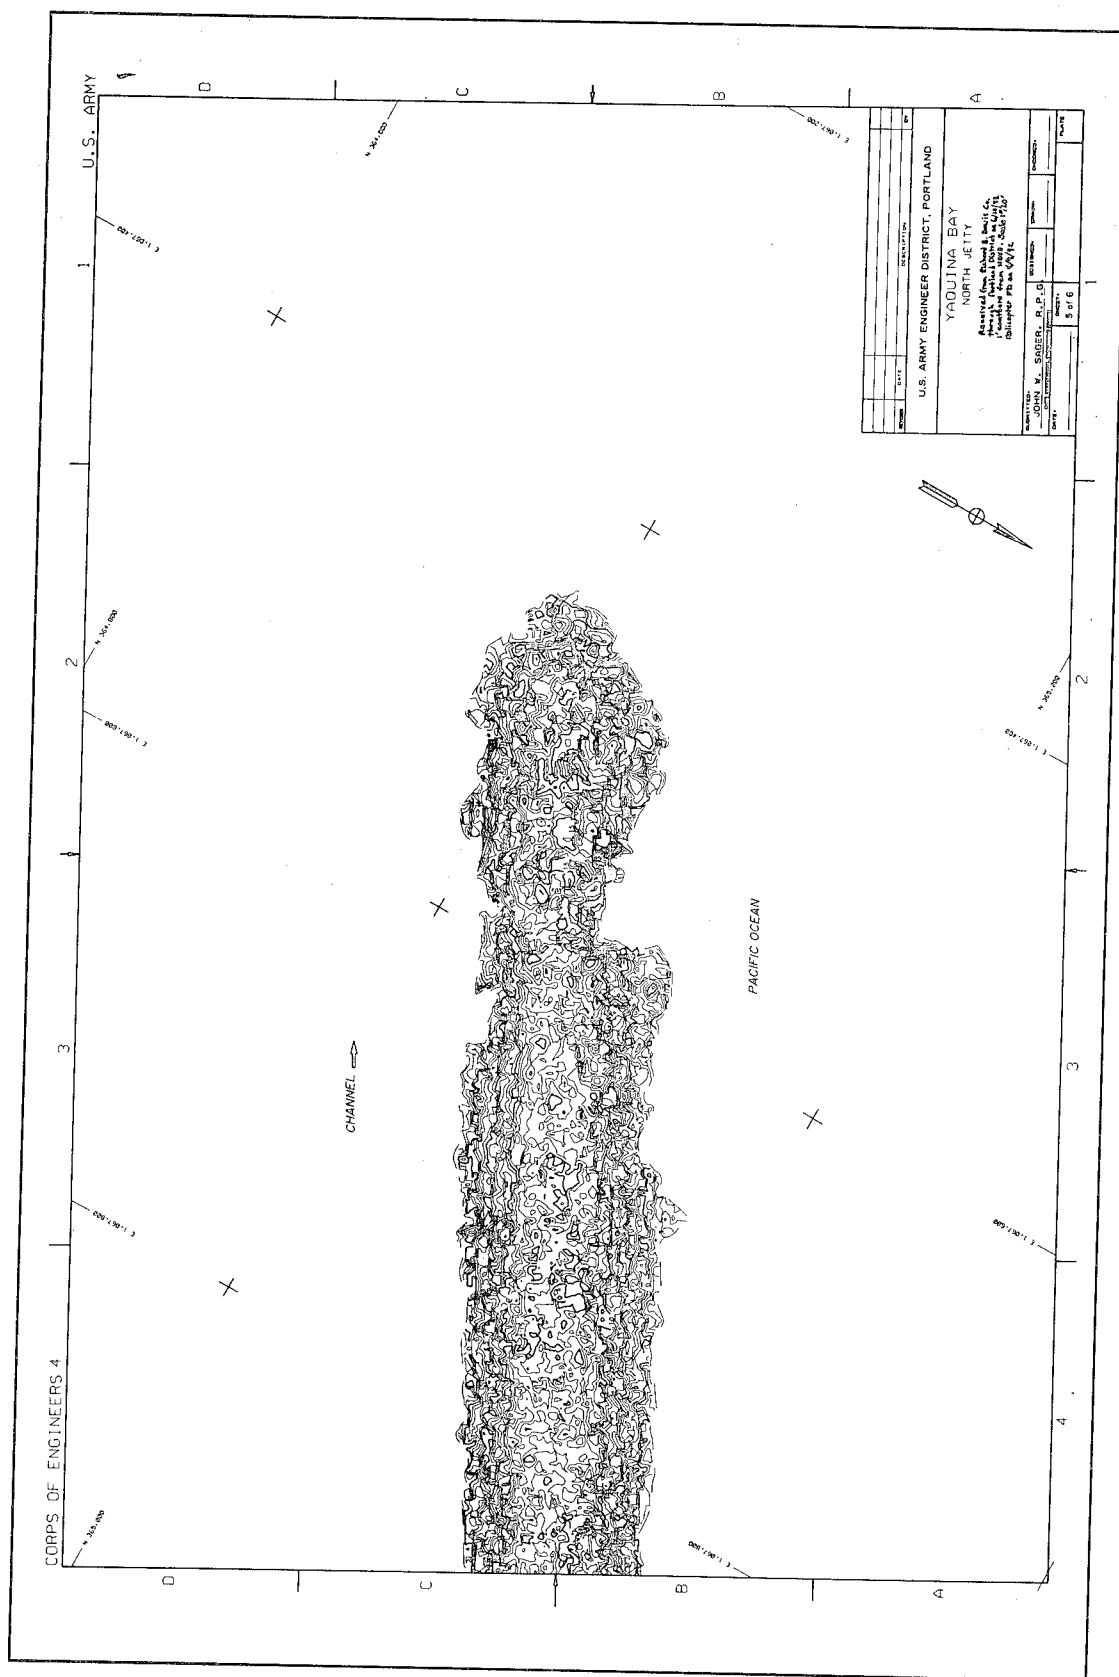
Figure 55. Elevation contours from the 1992 helicopter overflight

photogrammetry shown in Figure 40. A “mesh” orthographic projection of the jetty also was plotted from the stereo model, as shown in Figure 56.

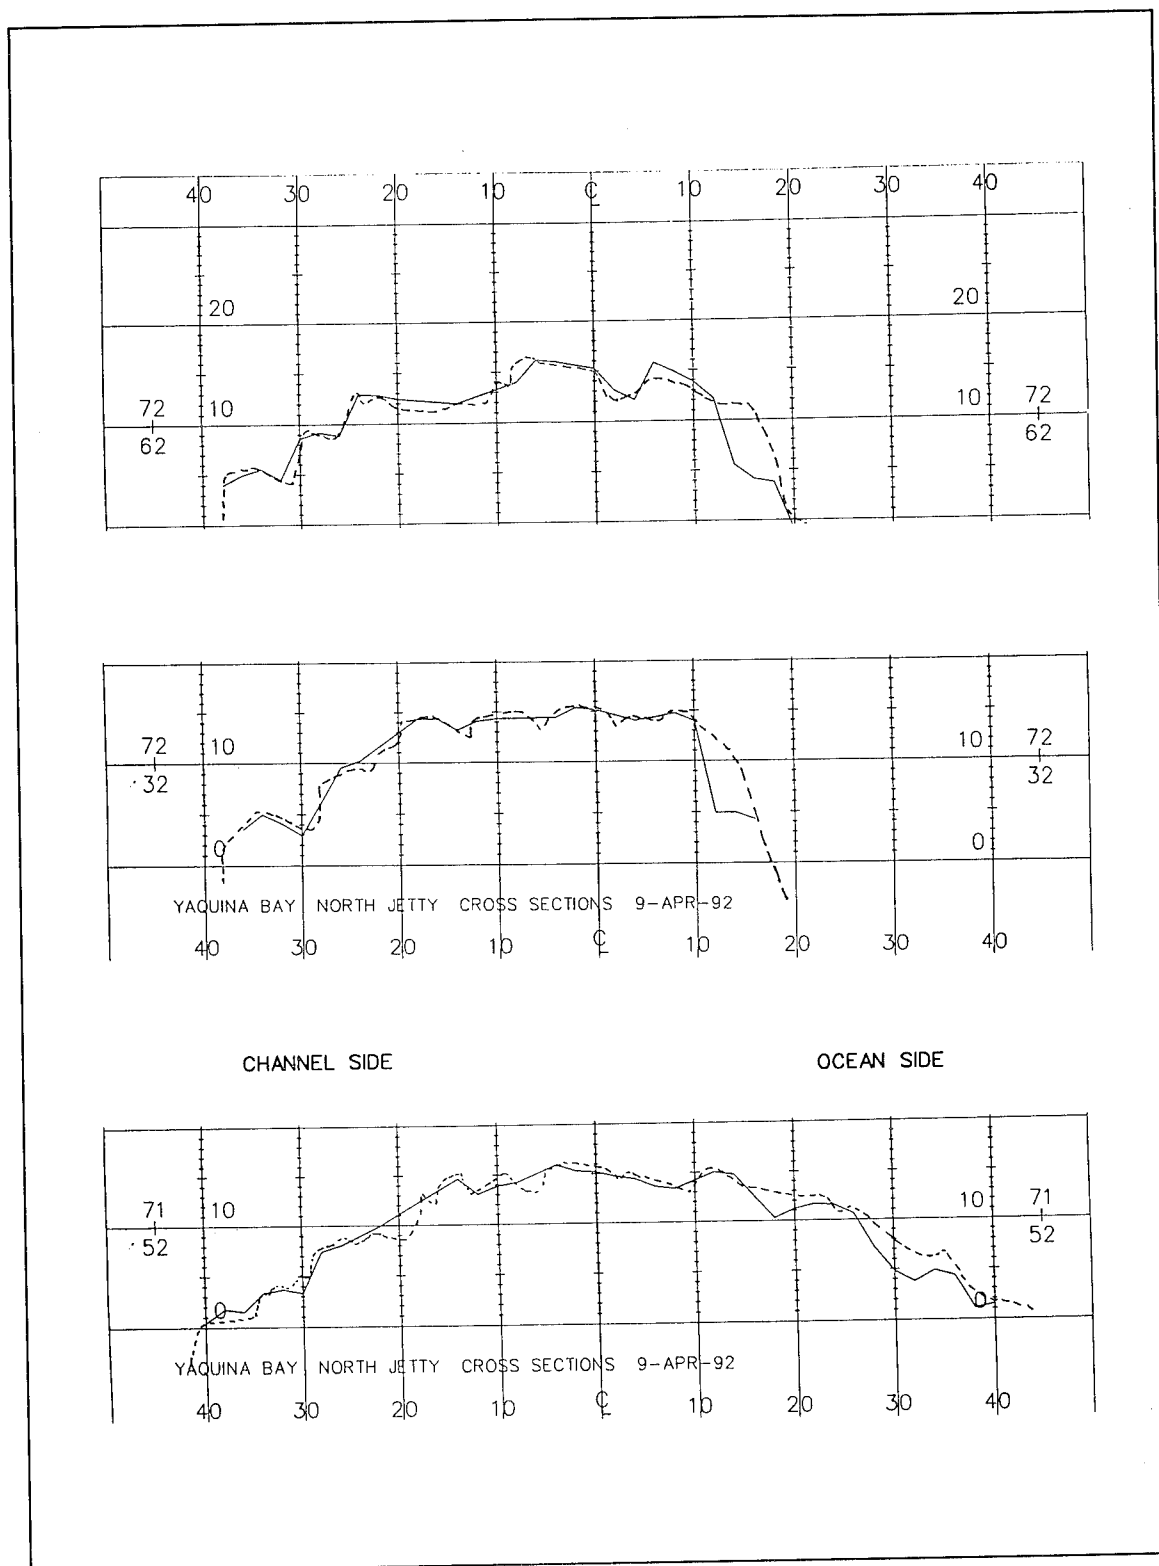
Figure 57. Comparison between 1992 helicopter (solid line) and fixed-wing (dashed line) cross sections

Figure 57 compares three of the 1992 helicopter cross sections (solid line) to the respective fixed-wing cross section (dashed line) that were obtained about 6 weeks earlier. For this limited comparison, reasonable agreement is observed overall, but isolated differences in elevation up to about 3 m (10 ft) are noted. This may be due to misalignment of the coordinate systems used in the two stereo models or interpretation of the stereo photographs. Whichever the case, it is not possible to state absolutely which profiles are correct without further ground-truth from land-based surveys.
